Manhole Inspection Summary

Manhole # S29CC1025MH

Insp Date: **12/13/06 5:03 PM**

Location Address: **3701 BEECH AVE**

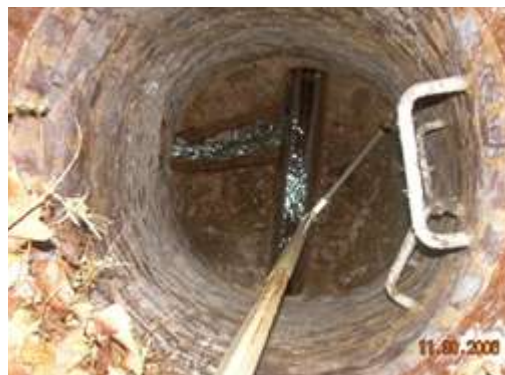
Top View

Offset: **0** (in.)

☐ Parged ☒ **Debris** (not Condition related)

Frame offset. Bench debris.

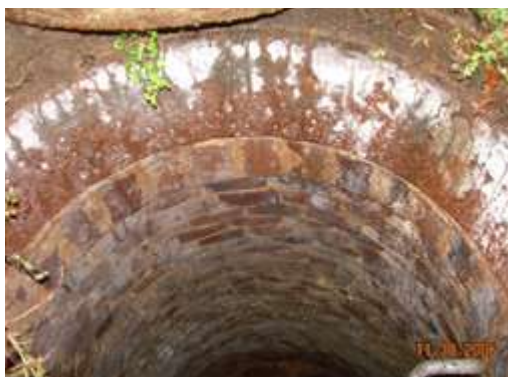
Defect

Infiltration: ☐ None ☒ **Joint** ☐ Cracks ☒ **Mortar** ☐ Roots ☐ Wall

Infiltration: ☐ None ☐ Joint ☐ Cracks ☒ **Mortar** ☐ Roots ☒ **Wall**

Adjustment, Corbel and Barrel infiltration.

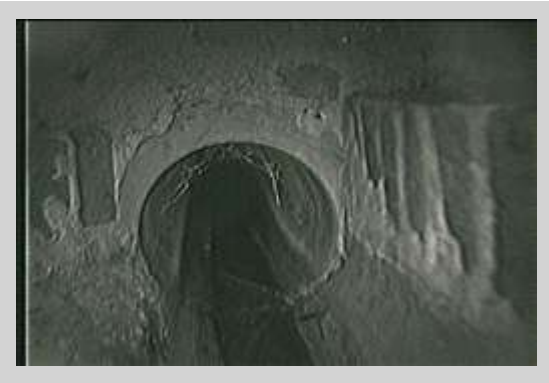
8 in. Circular Gravity Sewer Pipe Out @ 12 O'Clock

Invert Depth: **9.24** (ft.) Flow Characteristics: **Slow**

Infiltration: **None** Pipe Seal Cond: **Unknown**

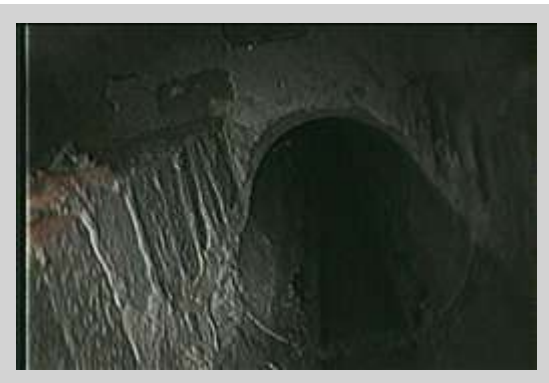
8 in. Circular Gravity Sewer Pipe In @ 6 O'Clock

Invert Depth: **9.21** (ft.) Flow Characteristics: **Slow**

Infiltration: **Evidence** Pipe Seal Cond: **Unknown**

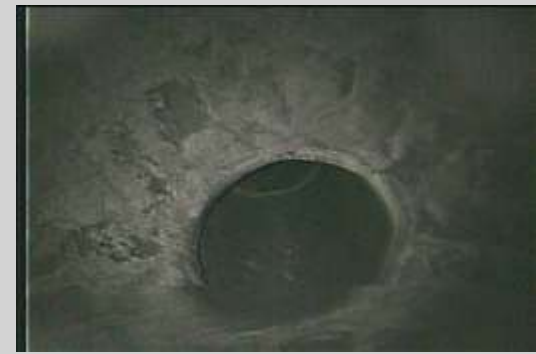
Pipe In @ 9 O'Clock

Invert Depth: **6.63** (ft.) Flow Characteristics: **None**

Infiltration: **Evidence** Pipe Seal Cond: **Unknown**

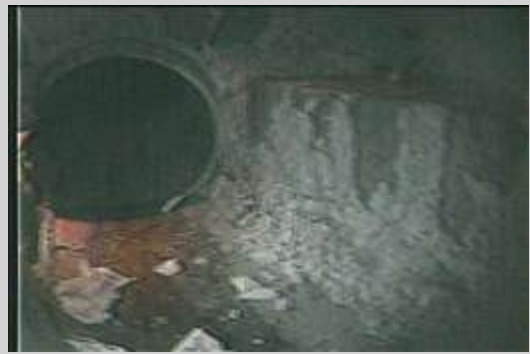
Drop In @ 9 O'Clock

Drop: **Outside** Rod and Bar

Angled: **Yes** Reading: **7.90** (ft.)

Inv Depth: **8.90** (ft.)

Drop Condition: **Open**
